**STRUCSURE**  
HOME WARRANTY

**FOUNDATION REPAIR PLAN**  
5537 Retger Avenue  
Dallas, TX 75214  
April 25, 2013

Re: Foundation Repair Review  
5537 Reigar Ave.  
Dallas, TX 75214

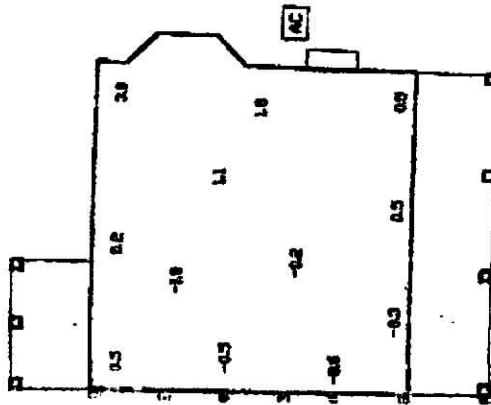
PIERS = 7

Note: Dimensions are approximate

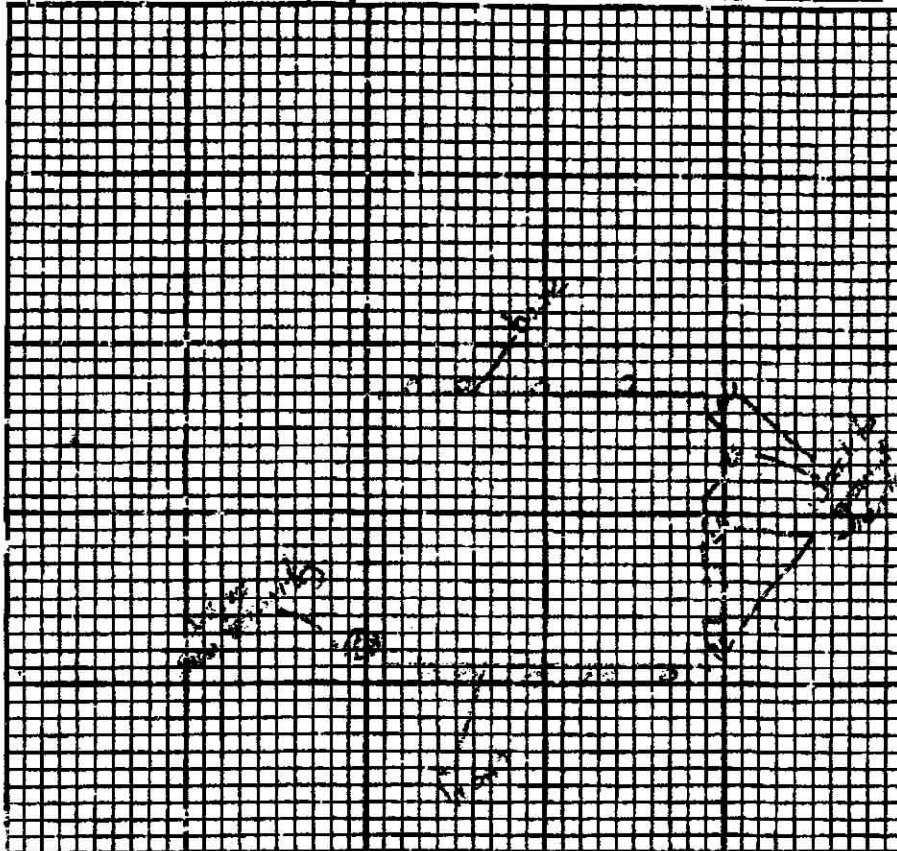
Diagram of Structure(s) Inspected

Additional Comments: Active sub-termites marked 93. Treatment recommended  
Lead to ground contact correction recommended

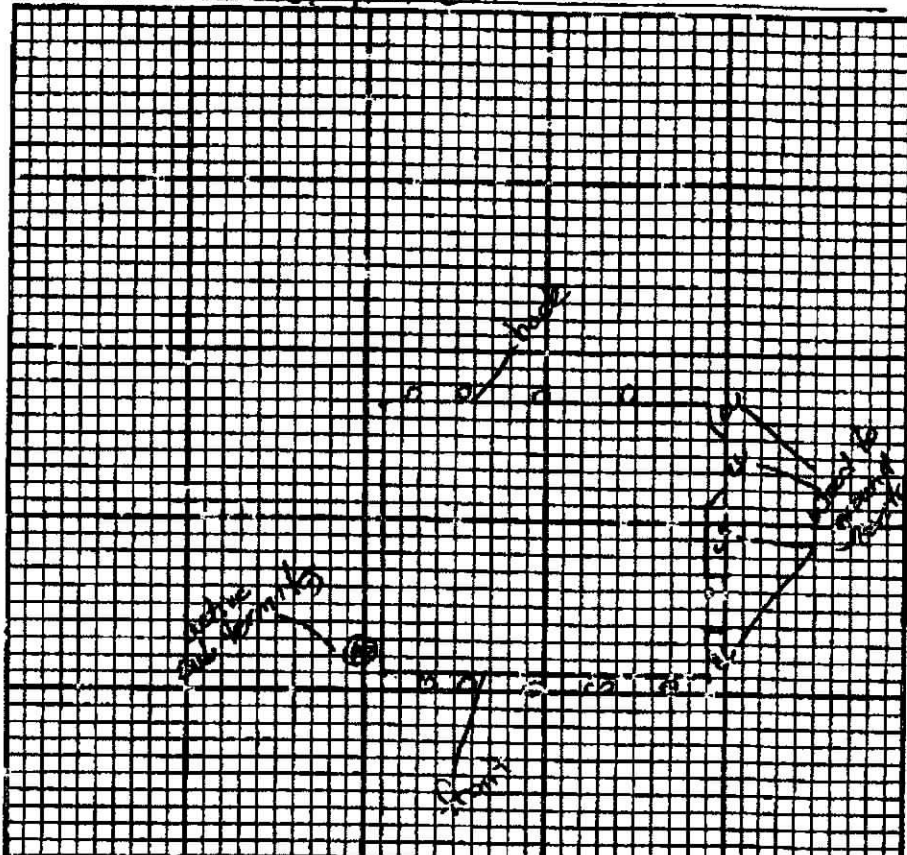
Diagram of Structure(s) Inspected

Additional Comments: Active sub termites marked AS. Treatment recommended  
Wood to ground contact correction recommended
